**Request for Proposals for Design-Build
Services for Construction Packages 2 - 3**

**Reference Material, Part C.13 – Site-Specific
Hazard Analysis of Adjacent Railroad
Operations**

HAZARD ANALYSIS REPORT

Site-Specific Hazard Analysis of Adjacent Railroad Operations in the CP02-03 Alignments

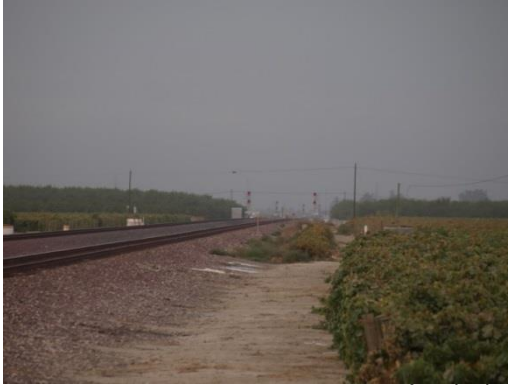
This segment, approximately 12,800 feet in length, extends from the north limit of CP0203 at East American Avenue to the northern limits of the Bowles crossover interlocking plant, north of E. South Avenue. The CHSRP alignment is planned to allow approximately 102 feet lateral distance to the nearest BNSF main track and approximately 10 feet above existing grade (only 5-6 feet above BNSF top-of-rail). Figure 4 shows the typical arrangement of the BNSF in this segment looking south (BNSF eastbound) toward the Bowles crossovers. The CHSRP trainway proposed to be located to the right of the BNSF tracks shown in the photo.

This segment represents the northern approach to the Bowles crossovers, a major point of stopping and meeting trains and hence a higher risk for derailments/collisions due to slack action, train meets, and other operations activities.

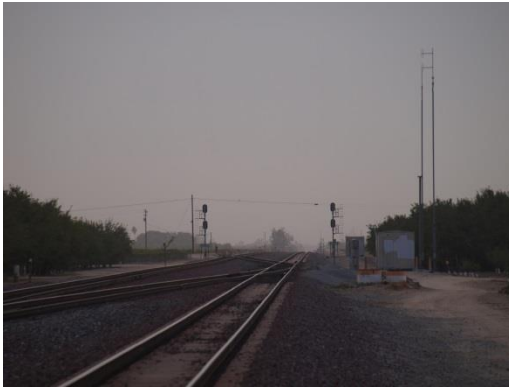
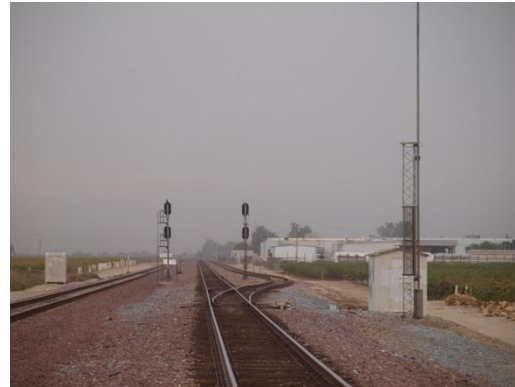
This segment, approximately 2,600 feet in length, encompasses the limits of the Bowles crossover interlocking. The CHSRP alignment is planned to allow approximately 102 feet lateral distance to the nearest BNSF main track and approximately 10 feet above existing grade (only 5-6 feet above BNSF top-of-rail). Figure 3-5a was taken from South Avenue looking north (BNSF westbound). Figure 3-5b was taken from South Avenue looking south (BNSF eastbound). The CHSRP trainway is proposed to be located to the left of the BNSF tracks shown in Figure 5a, to the right in Figure 5b.

This segment represents the entire limits of the Bowles crossovers plus the west switch to the Bowles siding on the west side of the BNSF right-of-way. Bowles is a major point of stopping and meeting trains and hence a higher risk for derailments/collisions due to slack action, train meets, and other operations activities.

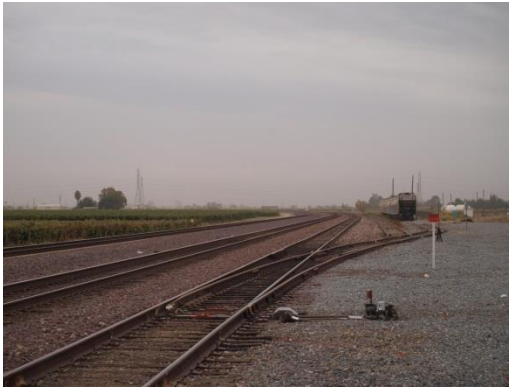
Figure 6

This segment, approximately 9,900 feet in length, extends from the south limits of the Bowles crossover and West Switch Bowles to the north limits of the East Switch Bowles. The BNSF alignment currently includes a 0 degree, 30 minute curve that is planned to be re-aligned into an even broader degree of curvature. The CHSRP alignment is planned to allow approximately 102 feet lateral distance to the nearest BNSF main track and approximately 10 feet above existing grade (only 5-6 feet above BNSF top-of-rail). Figure 3-6 was taken from Manning Avenue looking south (BNSF eastbound) with the BNSF industry/yard tracks to the right. The CHSRP trainway is proposed to be located to the right in Figure 6.

The Bowles siding is a controlled siding, with use authorized by the train dispatcher. The yard and industry tracks can be used without authority from the dispatcher, yet then cannot be accessed except from the Bowles siding. The yard tracks located south of Manning Avenue are used for short-term storage of intermodal cars and long-term storage of maintenance of way cars. There does not appear to be a great deal of day-to-day switching that takes place at Bowles. The industry located at Bowles,

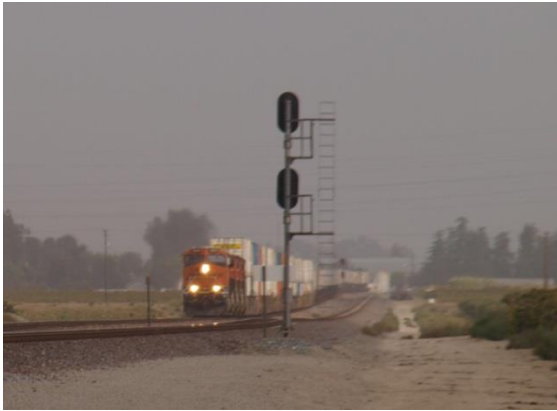
This segment, approximately 4,000 feet in length, extends from the north limits of the East Switch Bowles to the north limits CP Floral. Figure 7 shows the length of Segment CP0203-04, taken from Floral Road looking north. The CP Floral signals are in the foreground with the controlled signals for the East Switch Bowles in the distance.

The BNSF currently has two main tracks in service at this point. The Bowles siding is a controlled siding, with use authorized by the train dispatcher although it does not appear to be heavily used by through trains. CP Floral is the location where southbound trains are held to meet northbound trains coming off the single-track alignment south of CP Floral, and in fact a meet took place on the day of the site visit with the BNSF train shown in Figure 7 holding for a northbound Amtrak *San Joaquin*.

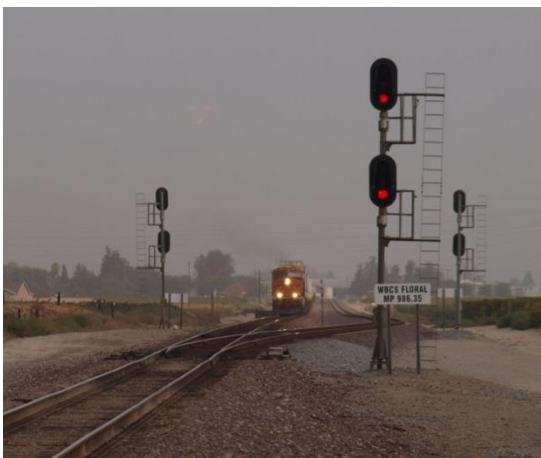
Figure 8

This segment, approximately 1,600 feet in length, encompasses the CP Floral interlocking. The BNSF alignment at this location consists of a main track turnout reducing from two main tracks to the north to one main track to the south. Segment CP0203-05 is shown in Figure 8, taken from Floral Road looking north.

The maximum authorized speed on the Main Track is 79 mph for passenger trains and up to 70 mph for freight trains, with a turnout speed of 50 mph for all types of trains to/from Main Track 1.

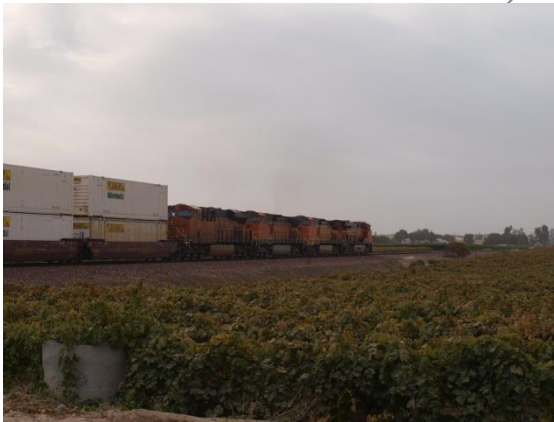
Figure 9

This segment, approximately 3,000 feet in length, extends from a point just south of the present Floral Road grade crossing to the north switch of the Monmouth industries. The BNSF alignment at this location consists of a single main track. Segment CP0203-06 is shown in Figure 9, taken from Floral Road looking south.

The BNSF alignment is relatively flat and tangent in this section. The surrounding property is private farmland. Most property is open and uncontrolled, providing direct access from the farm fields and dirt roads that terminate at the BNSF right of way.

The RHFA for Segment CP0203-06 is 270.30, resulting in a classification of *Tolerable*.

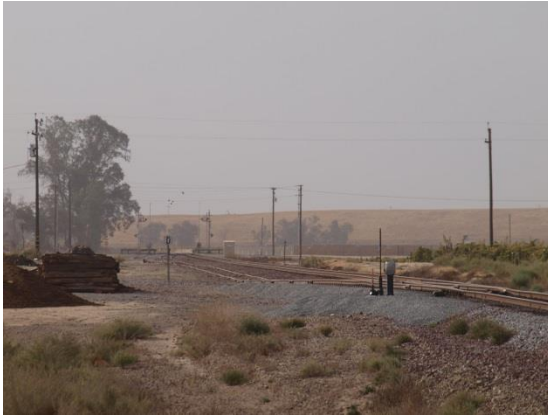
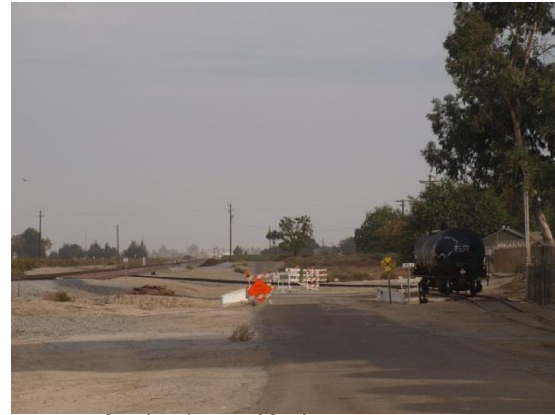
This segment, approximately 2,500 feet in length, encompasses the Monmouth siding to serve the several industries located there. Segment CP0203-07 is shown in Figure 10a taken from the north switch of the Monmouth siding looking south, and Figure 10b taken from the Nebraska Avenue grade crossing looking north.

The BNSF alignment at this location consists of a single main track and a short uncontrolled siding to support service to the Monmouth industries. There appears to be only one industry remaining in Monmouth: Vie-Del company winery and distillery. A hazmat-placarded tank car was spotted on the industry lead on the day of the site visit, although it was unclear whether this car was associated with the industry or not.

The BNSF alignment is relatively flat and tangent in this section. The surrounding property is private farmland to the west and both industrial or residential to the east. Topeka Street fronts the BNSF alignment to the east, but had been severed as a through road just prior to the site visit and did not appear to be re-opening. Property to the west is open and uncontrolled, providing direct access from the farm fields and dirt roads that terminate at the BNSF right of way. Property to the east, if Topeka Street were to be closed, provides a minimal level of access control although both Avenall Avenue and Overholser Avenue terminate at the BNSF right-of-way with appreciable level of intrusion protection for vehicles.

The RHFA for Segment CP0203-07 is 439.24, resulting in a classification of *Unacceptable*. This high-level RHFA is due primarily to the potential for industrial switching and stopping to set out or pick up cars, the two main track turnouts for the short siding, and the lack of access control measures along the right-of-way. If it can be demonstrated that the Monmouth industry or industries are used so infrequently so as to be considered a negligible hazard, then the RHFA should reduce to 337.87, resulting in a classification of *Undesirable*. Installation of an intrusion protection barrier per the requirements of Technical Memorandum 2.1.7 and an access control barrier on the east side of the BNSF alignment to prevent trespassing and vandalism should further reduce the RHFA to 304.09, resulting in a classification of *Tolerable*.

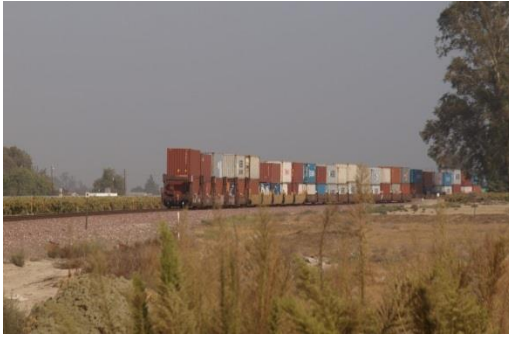
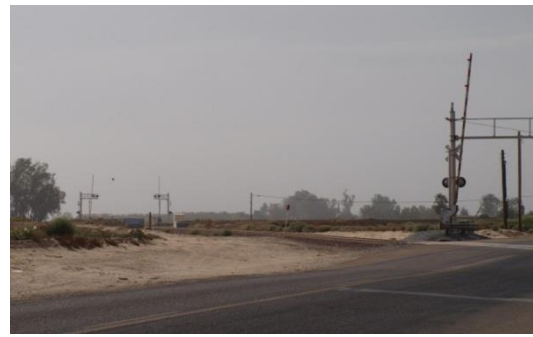
This segment, approximately 10,500 feet in length, encompasses the main track alignment between Monmouth and Conejo. The BNSF alignment in this segment consists of a single main track with a broad, sweeping curve of 0°30" that does not restrict speed. The segment includes two public at-grade crossings, Chestnut Avenue and Mountain View Avenue. The former is to be closed and the latter is to be grade separated. The segment also includes a trackside warning detector at MP 984.5 and a crossing of an irrigation canal with a 30" box culvert at MP 984.3. Segment CP0203-08 is shown in Figure 11a taken from Chestnut Avenue looking north, and Figure 11b taken of Mountain View Avenue grade crossing looking south.

The RHFA for Segment CP0203-08 is 304.09, resulting in a classification of *Tolerable*.

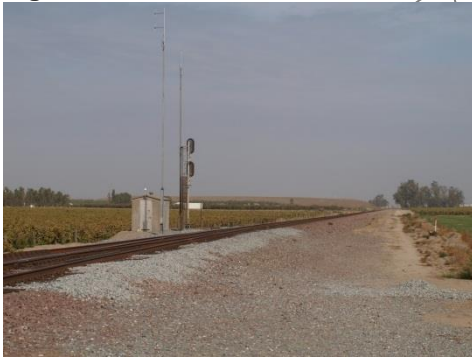
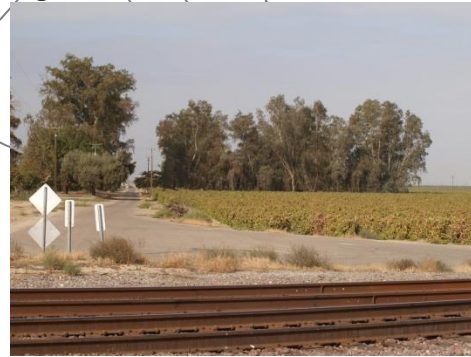
This segment, approximately 1,000 feet in length, encompasses the west siding switch at Conejo. The BNSF alignment in this segment consists of a single main track the splits into a main track and siding at the turnout. Turnout speed is 40 MPH. Kamm Avenue terminates at both sides of the BNSF right-of way with only signage for intrusion protection, no barriers. Segment CP0203-09 is shown in Figure 12a looking north and in Figure 12b looking west toward Kamm Avenue.

The RHFA for Segment CP0203-09 is 337.87, resulting in a classification of *Undesirable*. Installation of a vehicle intrusion protection barrier per the requirements of Technical Memorandum 2.1.7 should reduce the RHFA to 304.09, resulting in a classification of *Tolerable*.

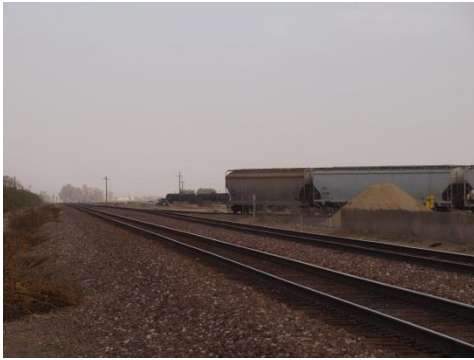
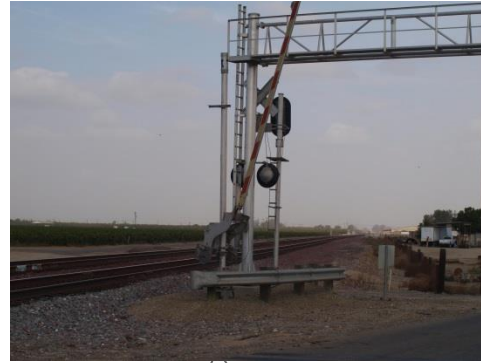
This segment, approximately 3,000 feet in length, encompasses the main track and controlled siding alignments at Conejo. The BNSF alignment in this segment is relatively tangent and level and includes several spur tracks serving industries to the east, most notably a rather large perishable warehouse called Imperial West Products and a bulk transload center for grain and liquids. The segment also includes one public at-grade crossing, Conejo Avenue. Segment CP0203-10 is shown in Figure 13a and Figure 13b.

The CHSRP alignment at this location begins to rise on a raised embankment and/or retained fill in order to cross over the BNSF alignment on an elevated structure south of Conejo Avenue. Because the elevation differential exceeds the 10 foot threshold for nullifying the hazard, the RHFA for Segment CP0203-10 is 0, resulting in a classification of *Eliminated*.

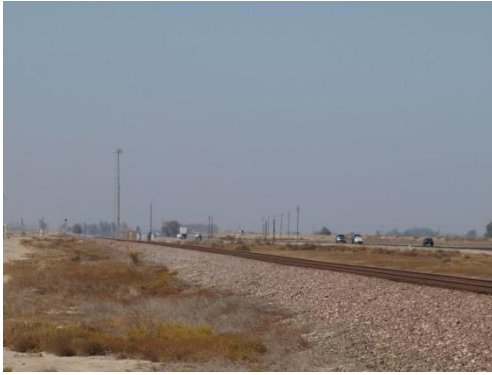
Figure 3-14

This segment, approximately 11,000 feet in length, encompasses the BNSF alignment north of Corcoran that is adjacent to SR-43. The BNSF alignment at this location is relatively tangent and level, with no access control measures in place other than signage – persons and vehicles are allowed direct access to the track. Segment CP0203-13 is shown in Figure 14 from the west side looking north east and with SR-43 in the far right of the picture.

The CHSRP alignment is to be placed in the strip of land between SR-43 and the BNSF main track. Because the alignment passes through an identified flood plain, the CHSRP track is to be placed on a raised embankment and/or retained fill with an elevation at least 10 feet above the BNSF main track. Despite the fact that the distance to the BNSF track center line is only 75 feet, the elevation differential in excess of 10 feet exceeds the minimum distance required to nullify the hazard, per the ARHRAM model. The RHFA for Segment CP0203-13 is 0, resulting in a classification of *Eliminated*.

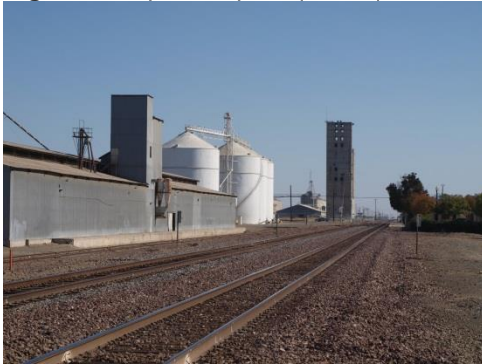
This segment, approximately 25,500 feet in length, encompasses the BNSF alignment through and around the City of Corcoran. The BNSF alignment through town has multiple grade crossings, industry spurs, and a CTC-equipped controlled siding. The alignment is wide open with regards to access control for vehicles and pedestrians. Segment CP0203-14 is shown in Figure 15 from Brokaw Avenue looking south, with the current Amtrak depot on the right and active industrial spurs on the left.

The CHSRP alignment through Corcoran is located to the east of the downtown area in an at-grade configuration, well beyond the maximum 125 foot distance for consideration of adjacent railroad hazards the RHFA for Segment CP0203-12 is 0, resulting in a classification of *Eliminated*.

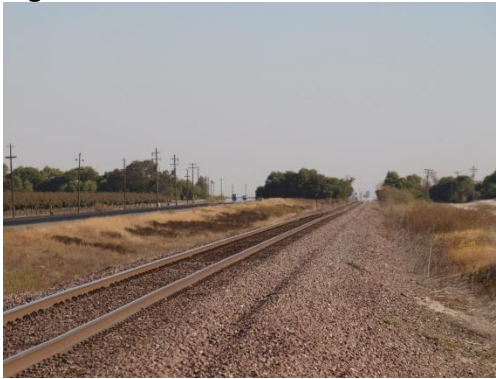
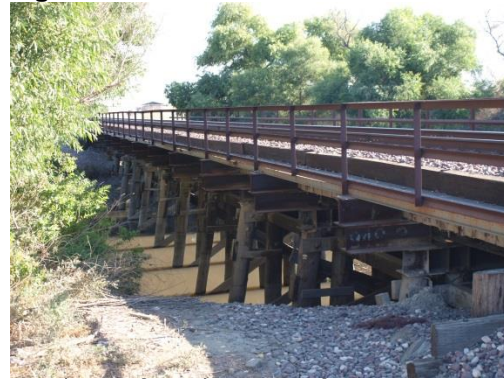
pedestrians. Segment CP0203-15 is shown in Figure 16a from Avenue 144 looking south toward the Tule River. Figure 16b shows the Tule River Bridge itself.

The CHSRP alignment crosses over the BNSF alignment and SR-43 on a long, skewed elevated structure, with support columns projected to be located beyond 25 feet from BNSF track centers. The CHSRP alignment remains elevated over Avenue 144 and the Tule River, landing at grade west of the BNSF alignment south of the Tule River at the current location of the Avenue 136 highway grade crossing (to be closed). Because the elevation differential exceeds the 10 foot threshold for nullifying the hazard, and the requirement (satisfied in the 15% drawings for Preliminary Engineering) satisfies the requirement for 25 foot setback from BNSF track center lines for bridge supports (per AREMA standards) the RHFA for Segment CP0203-15 is 0, resulting in a classification of *Eliminated*.

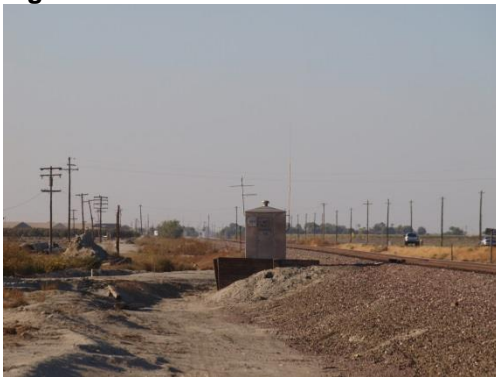
This segment, approximately 15,000 feet in length, encompasses the BNSF alignment south of the Tule River to the north siding switch at Angiola. The BNSF alignment is relatively tangent and level and encounters at-grade crossings at Avenue 128 and Avenue 120. There are no main track turnouts or other special trackwork. The alignment is wide open with regards to access control for vehicles and pedestrians. Segment CP0203-16 is shown in Figure 17 from Avenue 120 looking north toward the trackside warning detector at MP 943.7. The CHSRP alignment will be to the left in the photo.

The RHFA for Segment CP0203-16 is 270.30, resulting in a classification of *Tolerable*.

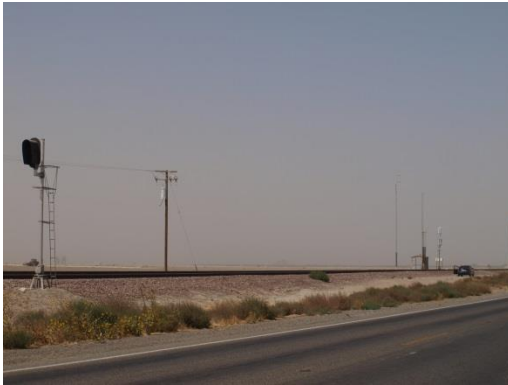
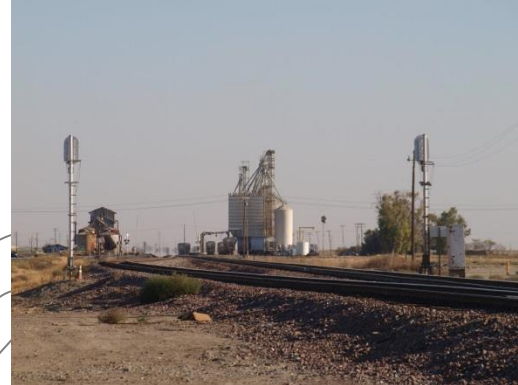
This segment, approximately 1,000 feet in length, encompasses the BNSF alignment only at the West Siding Switch (directional north) at Angiola. The BNSF alignment is relatively tangent and level and encounters no grade crossings in the segment. There is one main track turnout for the Angiola siding, controlled by the BNSF train dispatcher at the San Bernadino ROC. The alignment is wide open with regards to access control for vehicles and pedestrians, within sight of SR-43. Segment CP0203-17 is shown in Figure 18a, West Siding Switch at Angiola taken from SR-43. Figure 18b looks from the switch south toward the industries at Angiola. The CHSRP alignment will be to the right in the photos.

The RHFA for Segment CP0203-17 is 337.87, resulting in a classification of *Undesirable*. This medium-level RHFA is due primarily to the West Siding Switch Angiola where trains frequently meet, and the lack of access control measures along the right-of-way. Providing increased intrusion protection to the east side of the BNSF right-of-way in the form of access control for pedestrians and appropriate vehicle intrusion protection should reduce the RHFA to 304.09, sufficient to move the classification into the category of *Tolerable*.

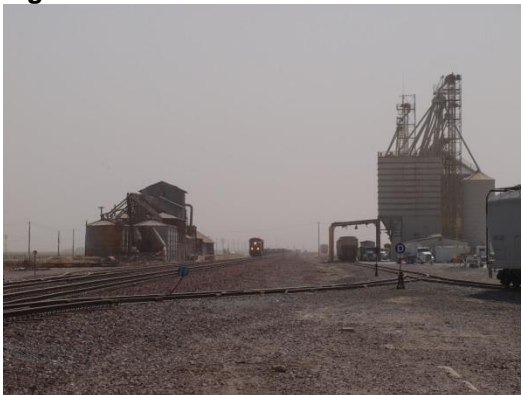
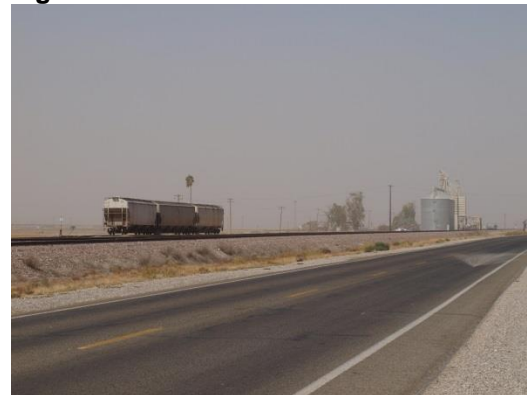
This segment, approximately 8,000 feet in length, encompasses the BNSF alignment for the entire length of the Angiola controlled siding. The BNSF alignment is relatively tangent and level and includes a highway-rail grade crossing at Avenue 112, north of the Angiola industries. There is a main track and controlled siding, both controlled by the BNSF train dispatcher at the San Bernadino ROC. The alignment is wide open with regards to access control for vehicles and pedestrians, both from the industries on the west side and SR-43 on the east side. Segment CP0203-18 is shown in Figure 19a from Avenue 112 looking south and in Figure 19b from SR-43 looking north toward the industries at Angiola.

The industry on the west side, PFFJ, LLC appears to be a feed mill taking inbound carloads of grain for distribution. The CHSRP alignment is to pass through this area, necessitating the relocation of this industry and removing the main track turnouts and spur tracks. The industry on the east side is derelict and appears to be out of service.

The RHFA for Segment CP0203-17 is 371.66, resulting in a classification of *Unacceptable*. This high-level RHFA is due primarily to the industrial switching activities and main track turnouts presently found at Angiola. Relocating the industries away from the segment should reduce the RHFA to 304.09, sufficient to move the classification into the category of *Tolerable*.

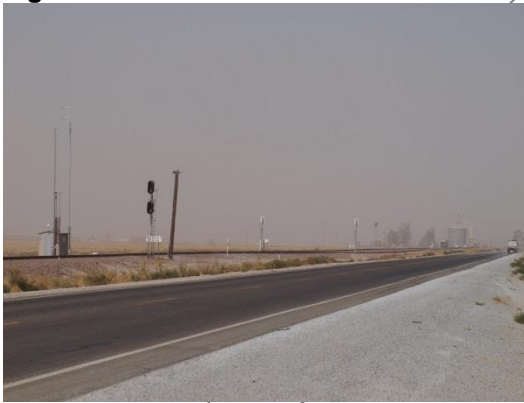
Figure 20

This segment, approximately 1,000 feet in length, encompasses the BNSF alignment only at the East Siding Switch (directional south) at Angiola. The BNSF alignment is relatively tangent and level and encounters no grade crossings in the segment. There is one main track turnout for the Angiola siding, controlled by the BNSF train dispatcher at the San Bernadino ROC. The alignment is wide open with regards to access control for vehicles and pedestrians, within sight of SR-43. Segment CP0203-19 is shown in Figure 20, East Siding Switch at Angiola taken from SR-43 and with the Angiola industries in the distance to the north. The CHSRP alignment will be to the left in the photo on the far side of the BNSF main track.

The RHFA for Segment CP0203-19 is 337.87, resulting in a classification of *Undesirable*. This medium-level RHFA is due primarily to the East Siding Switch Angiola where trains frequently meet, and the lack of access control measures along the right-of-way. Providing increased intrusion protection to the east side of the BNSF right-of-way in the form of access control for pedestrians and appropriate vehicle intrusion protection should reduce the RHFA to 304.09, sufficient to move the classification into the category of *Tolerable*.

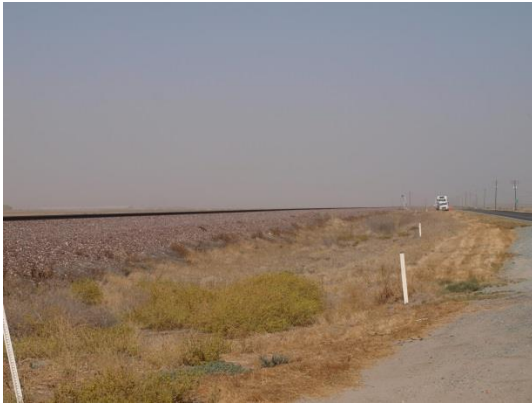
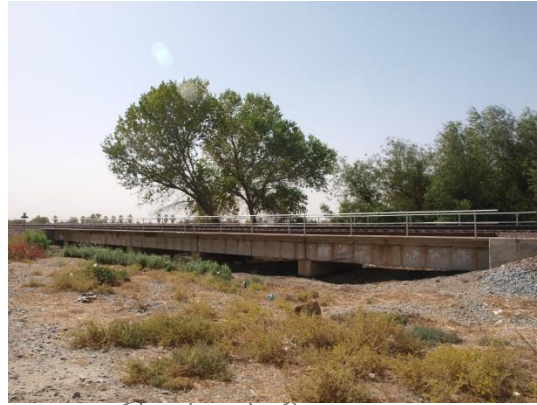
This segment, approximately 24,000 feet in length, encompasses the BNSF alignment south from the East siding Switch Angiola to just south of the Deer Creek crossing, MP 936.5. The BNSF alignment is relatively tangent and level and encounters only one public highway-rail grade crossing at Avenue 88, MP 938.84. There are no main track turnouts and only one bridge structure at Deer Creek, a ballasted-deck concrete trestle. The alignment is wide open with regards to access control for vehicles and pedestrians, within sight of SR-43. Segment CP0203-20 is shown in Figure 21a from SR-43 and the Deer Creek Bridge is shown in Figure 21b. The CHSRP alignment will be to the left in Figure 21a on the far side of the BNSF main track.

The RHFA for Segment CP0203-20 is 270.30, resulting in a classification of *Tolerable*.
